CONNECTICUT RIVER BASIN
KEENE, NEW HAMPSHIRE

GOOSE POND DAM
NH 00101
NHWRB 126.03

PHASE I INSPECTION REPORT
NATIONAL DAM INSPECTION PROGRAM

FEBRUARY 1980

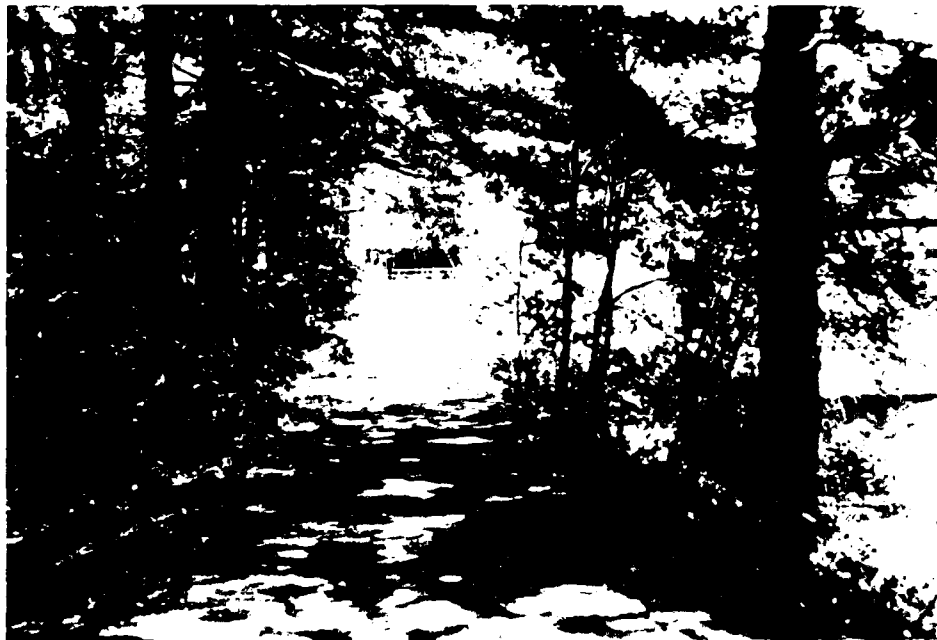
1. Crest of Dam from Left Abutment

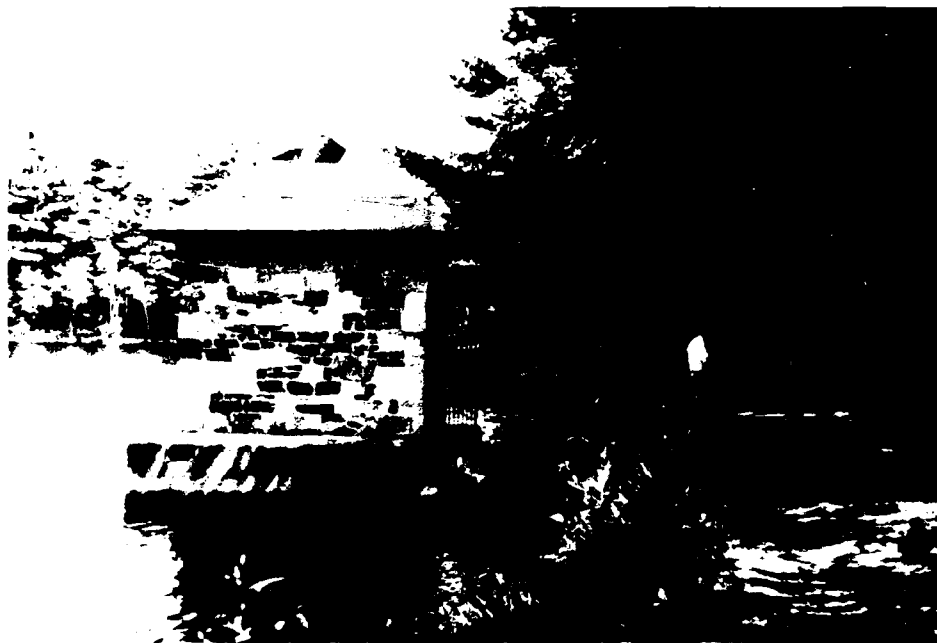
2. Crest of Dam and Gatehouse from Right Side

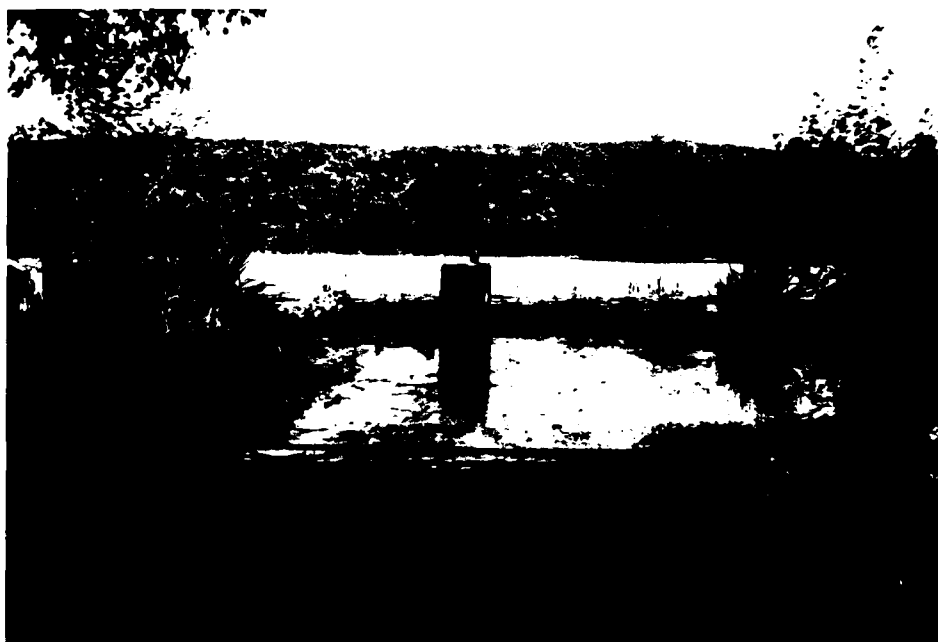
8. Spillway
